Division of Waste Management Solid Waste Section

Date of Site Inspection: June 30, 2014 Date of Last Inspection: October 17, 2011

Hinshaw's LCID Landfill 4337 S. NC Hwy 49 Burlington, NC 27215

Comprehensive Inspection (to ensure that the notified land clearing and inert debris (LCID) landfill is in compliance with 15A North Carolina Administrative Code (NCAC) 13B .0563, .0564, and .0566)

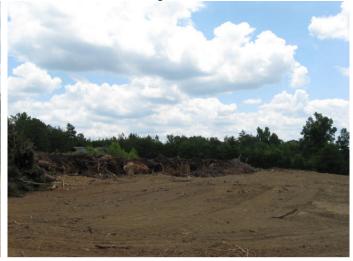
- 4. Material is placed atop the LCID landfill in shallow lifts. Mr. Hinshaw stated that it is covered with soil every 30 days and that land clearing debris (LCD) currently in the active area/lift has been recently brought on site.

LCD lift – view from right rear

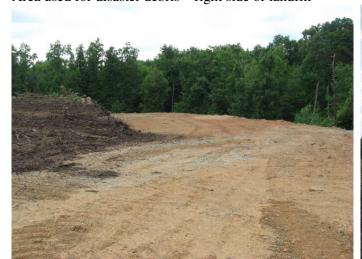
- 11. Hinshaw's LCID landfill is also a temporary disaster debris staging site (TDDSS). The TDDSS number is: DS01-014.
- 12. The TDDSS was activated on April 2, 2014 and deactivated on June 25, 2014.

- 13. During the inspection Mr. Hinshaw stated that all material associated with the March 2014 ice storm was covered with soil.
- 14. Access roads are of all-weather construction.

Area used for disaster debris – right side of landfill
